The Misconfigured Network

How common network misconfigurations impact ICS reliability and security

SANS 2019

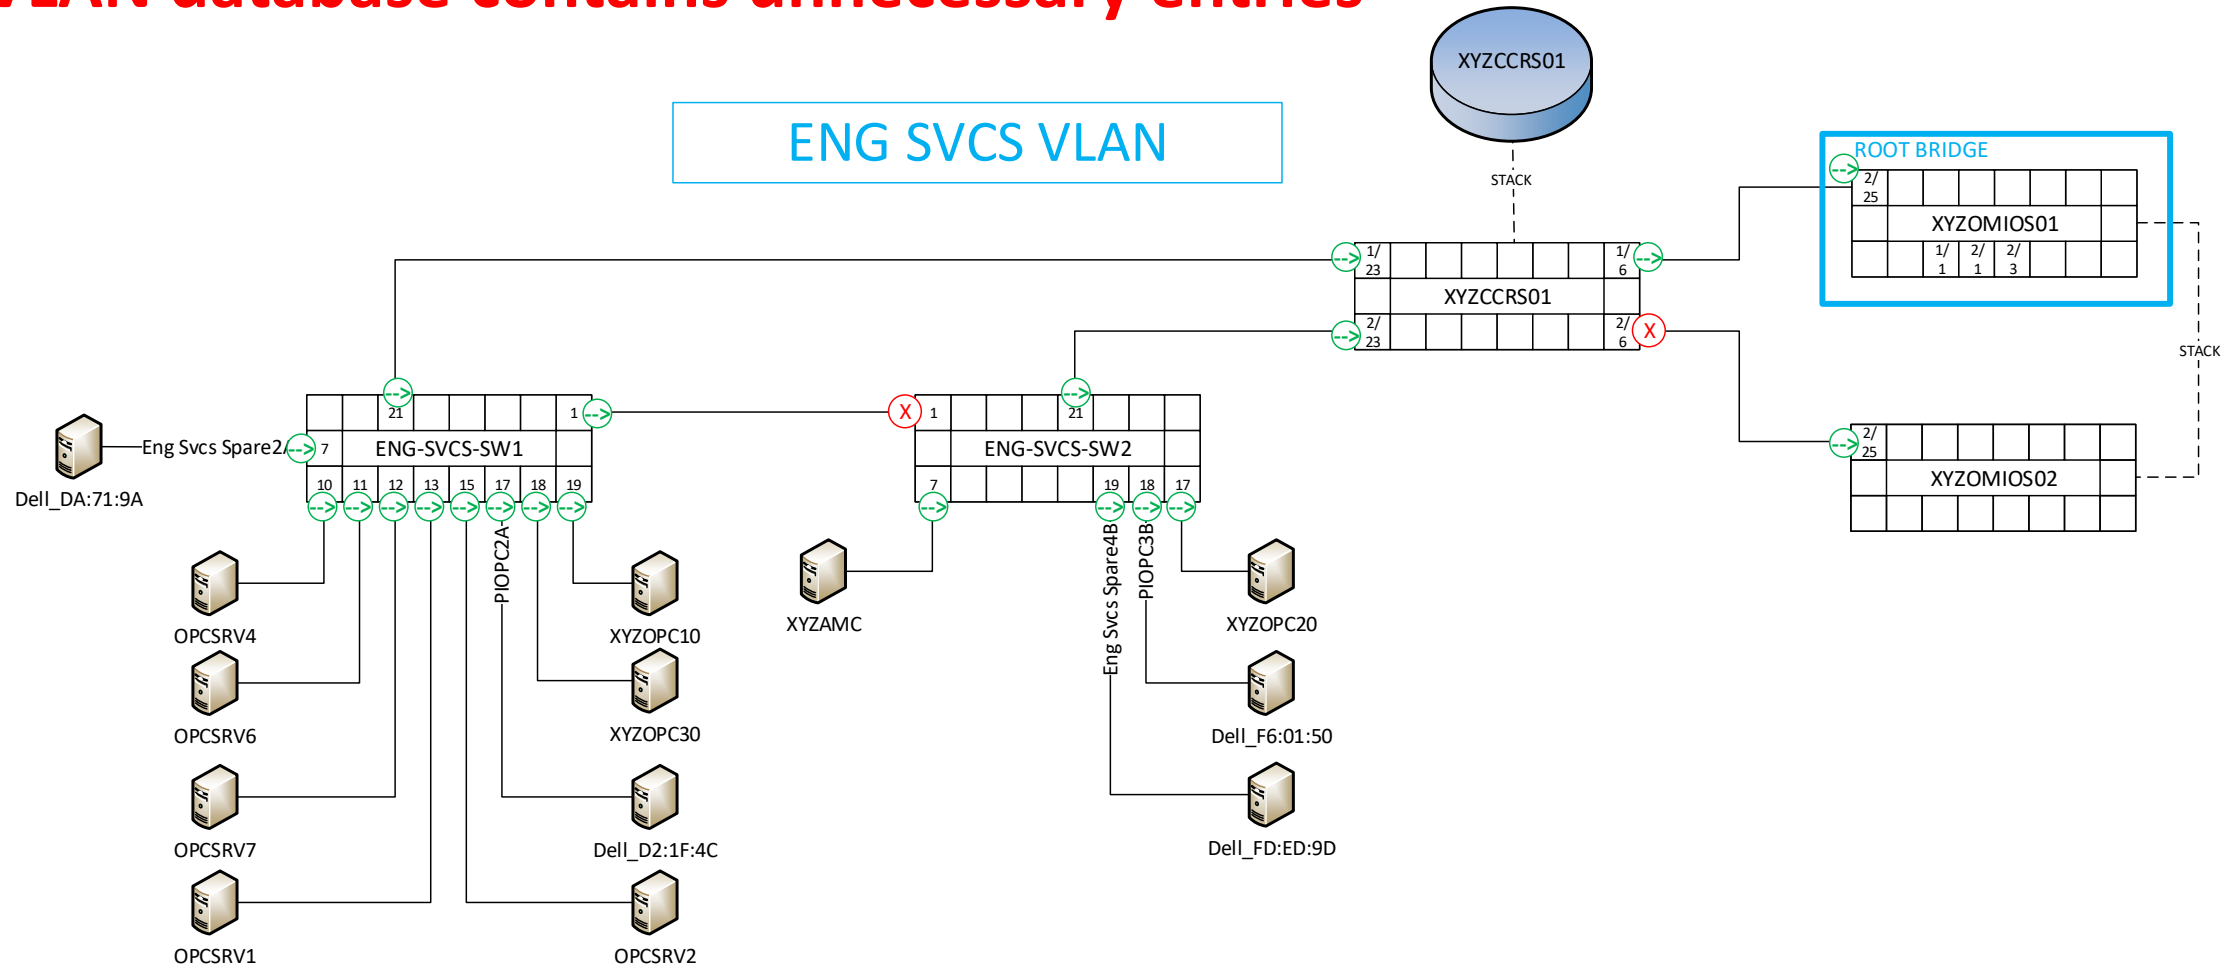
Spanning Tree Topology Not Enforced

Spanning tree topology not enforced &
VLAN database contains unnecessary entries

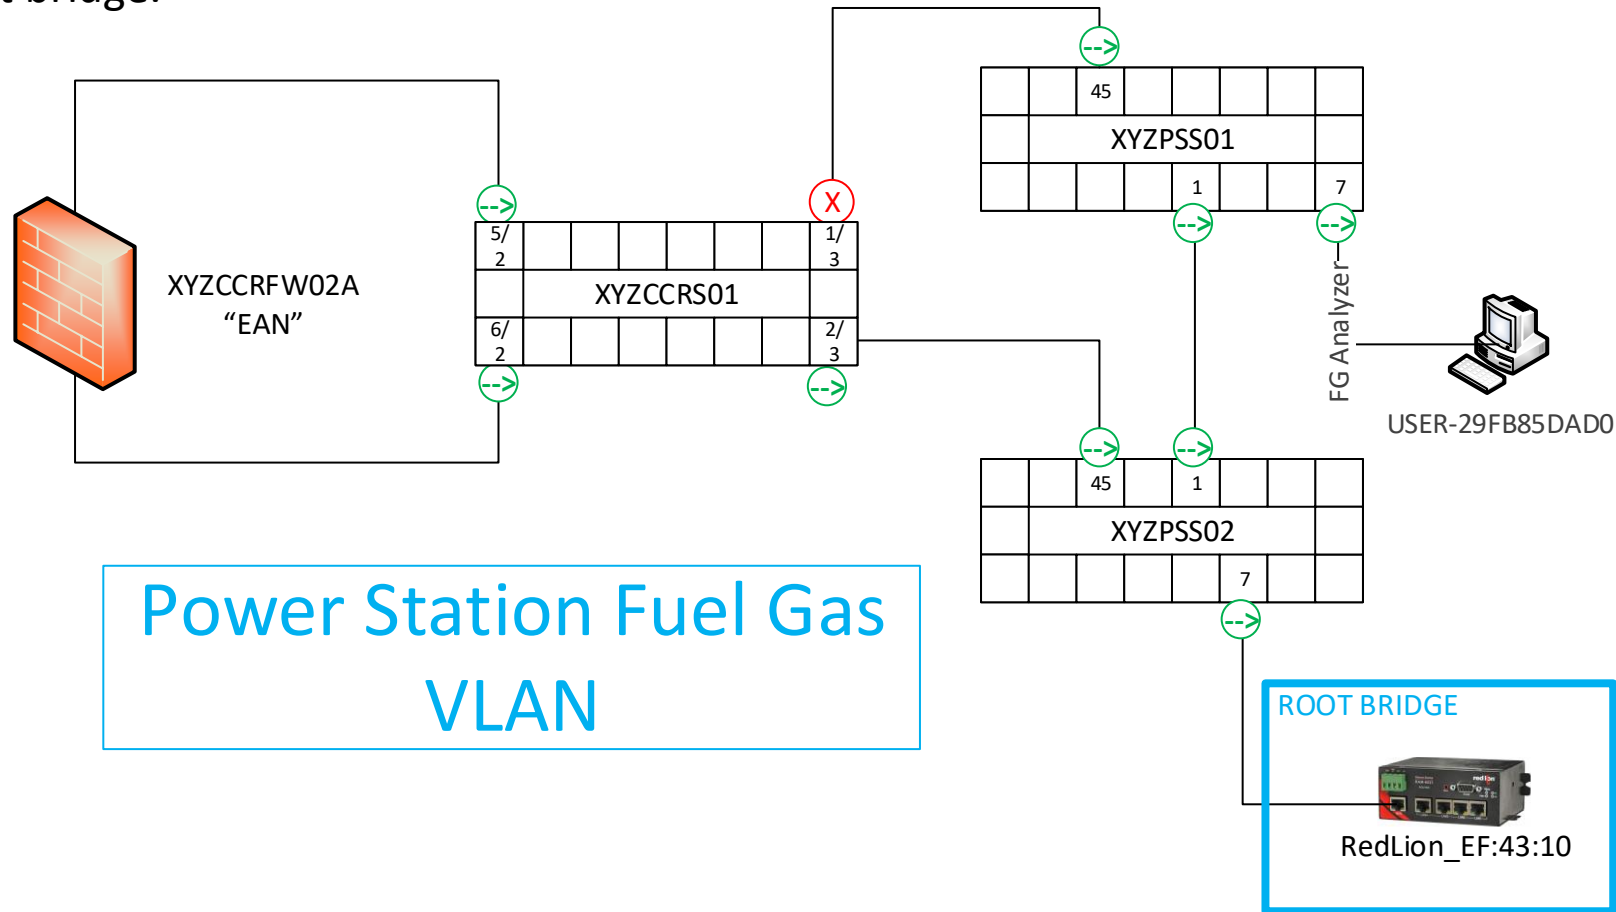
End Device Becomes Root Switch

Access port participating in STP election

If STP priorities are left as default and access ports are allowed to participate in the election, end devices can become the root bridge.

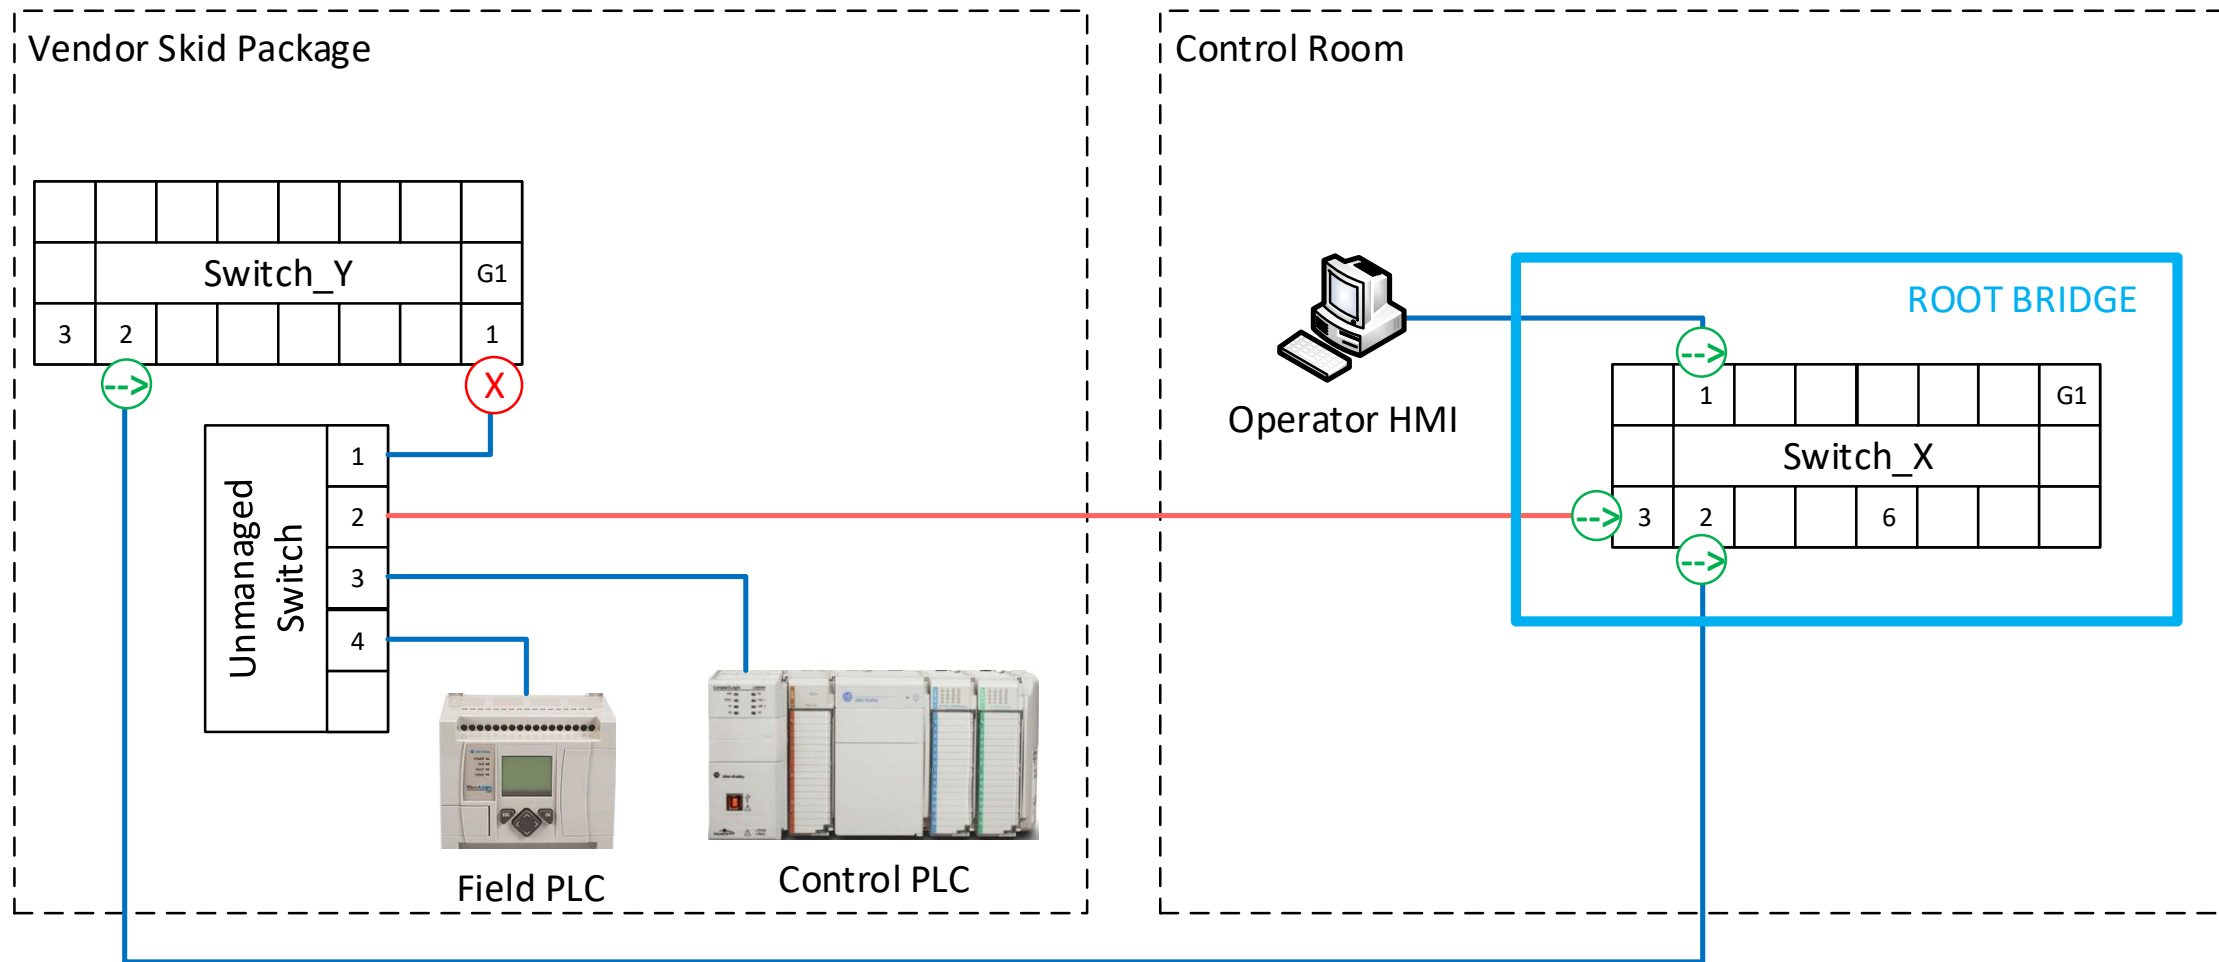
Demonstration 4 – Prevent Switching Loop

STP topology is enforced and switch ports are configured correctly

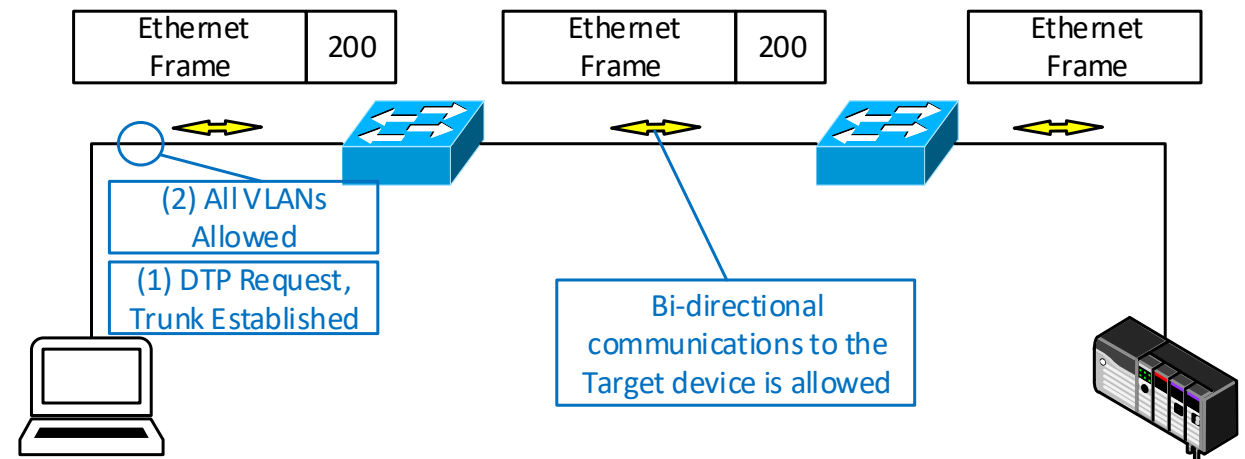
Also known as switch spoofing, allows unauthorized access to another VLAN by negotiating a trunk with the switch

► Misconfigurations that can introduce this vulnerability

- Unused (trunk) port administratively UP
- Interface with default configuration, not configured

► Mitigations

- Move unused ports to an unused VLAN
- Don't allow unused VLAN over trunks
- Explicitly configure the port to be an access port
- Configure access ports to "nonegotiate"
- Administratively shutdown unused ports

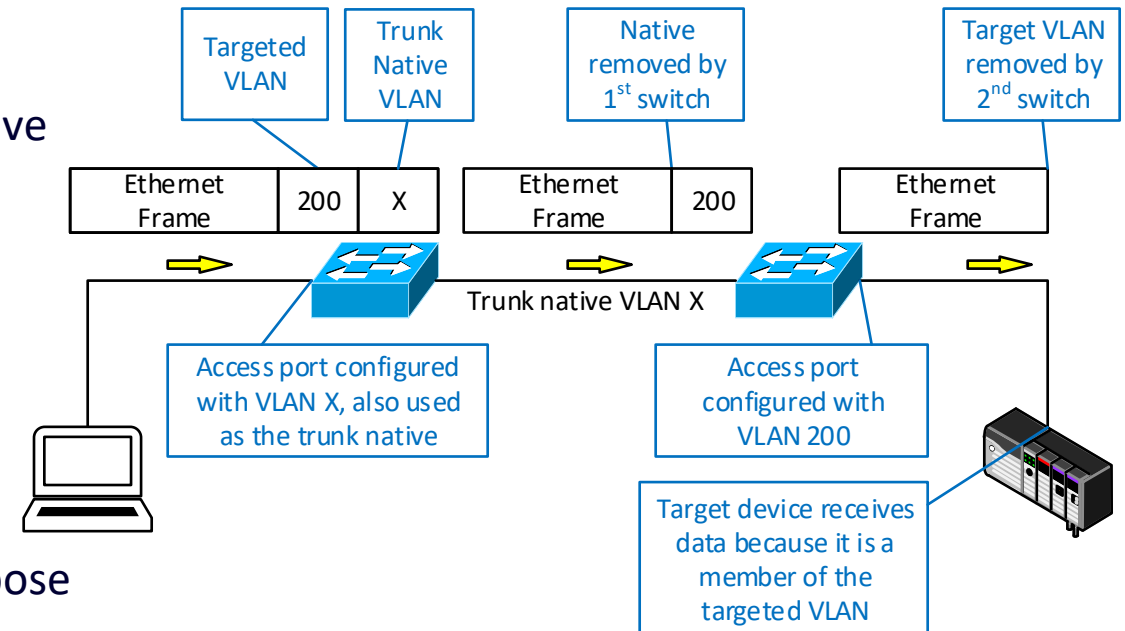
Allows traffic from one VLAN to transmit data to a device in different VLAN

► Misconfigurations that can introduce this vulnerability

- Unused (trunk) port administratively UP
- Interface with default configuration, not configured
- Access port configured with VLAN used for trunk native
- Access port assigned to default VLAN 1
- Trunk native VLAN allowed over trunk
- Trunk port configured to allow all VLANs

► Mitigations

- Assign an unused VLAN as the trunk native
- Avoid using the trunk native VLAN for any other purpose
